FIELD TRIAL

SURGE PROTECTION SYSTEM FOR LIGHTING PROTECTION

Test conducted by:
Thomas and Betts Power Solutions
5900 Eastport Blvd. Bldg V
Richmond, VA 23231-4453

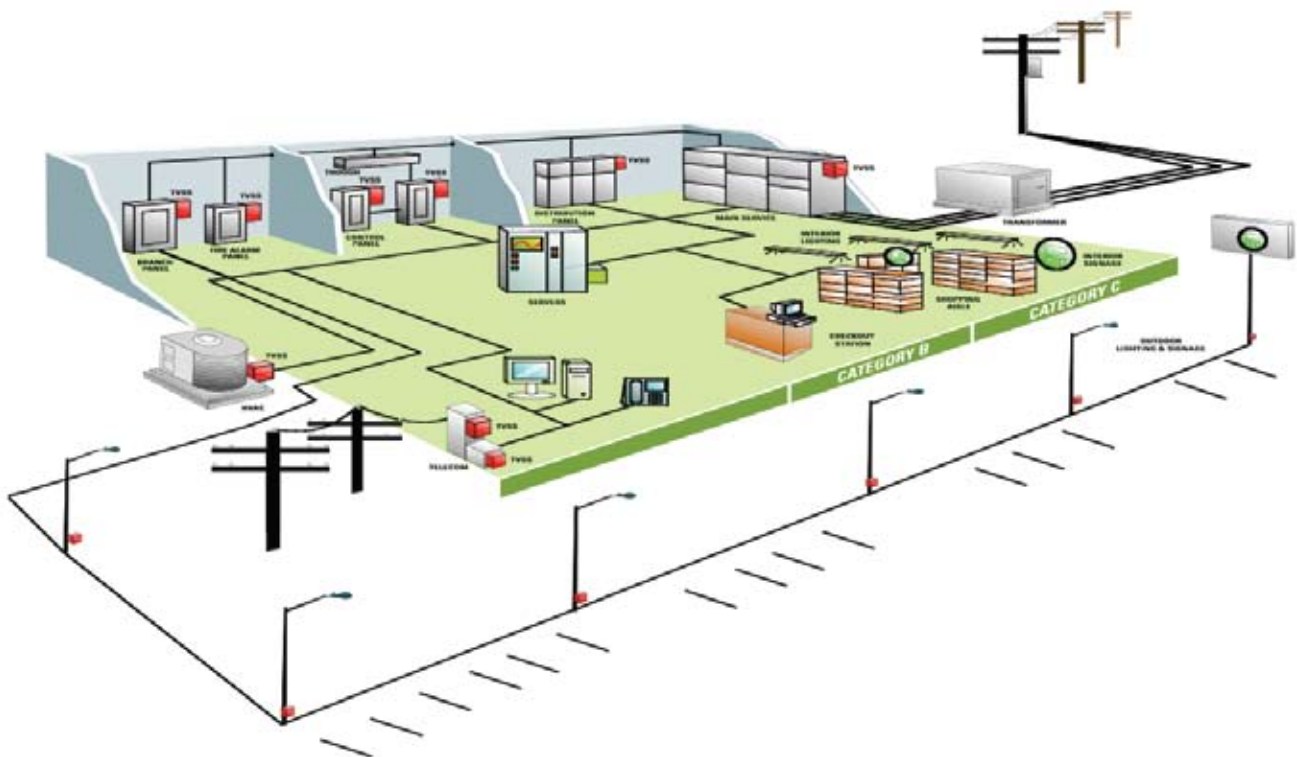
It appeared the problem had been identified and a suitable solution had been identified as well. The next step was to apply the proposed solution in the field. All ten stores had small surge protection devices installed at each parking lot light pole and more robust surge protectors installed on the panels inside. The diagram below shows a typical store layout and where surge protectors were installed.
