## **Case Study**

# Johns Hopkins University School of Medicine

# The Preclinical Building – Baltimore, MD

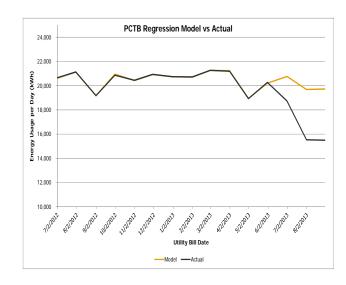
The point at which the usage line splits from the model line represents the time of PQI's Solution installation.

√ 1,587,332 = Annual kWh savings
